Manhole Inspection Summary

Manhole # S37CC_037MH

Insp Date: **12/3/08 1:10 PM**

Location Address: **401 e. eager st**

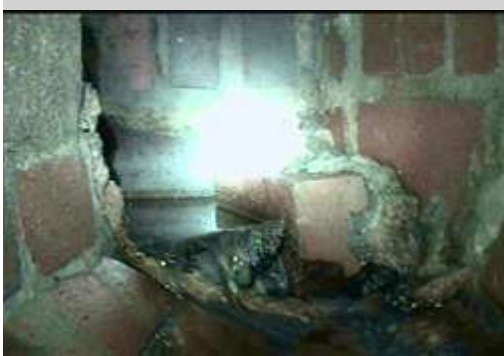
Misc channel debris

channel debris

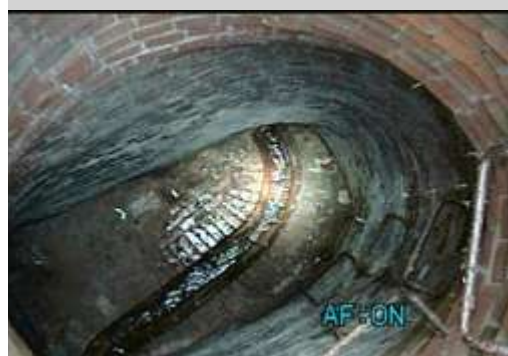
Defect 1

Steps Count: **7** Missing: **0** ☒ **Corroded**

Corroded Steps

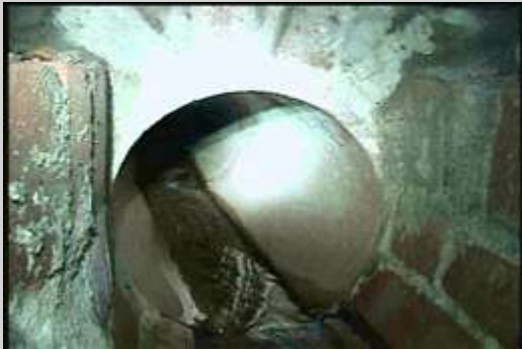
12 O'Clock Outflow

10 in. Circular Gravity Sewer
Pipe Out @ 12 O'Clock

Invert Depth: **13.80** (ft.) Flow Characteristics: **Slow**

Infiltration: **None** Pipe Seal Cond: **Unknown**

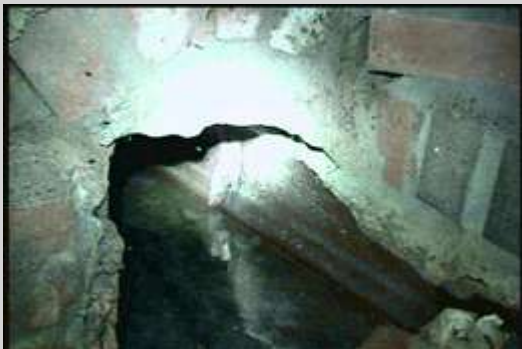
7 O'Clock Inflow

10 in. Circular Gravity Sewer
Pipe In @ 7 O'Clock

Invert Depth: **13.71** (ft.) Flow Characteristics: **Slow**

Infiltration: **None** Pipe Seal Cond: **Unknown**
